KERNODLE LAKE DAM NO. 2

JACKSON COUNTY, MISSOURI

MO 20374

PHASE 1 INSPECTION REPORT NATIONAL DAM SAFETY INSPECTION

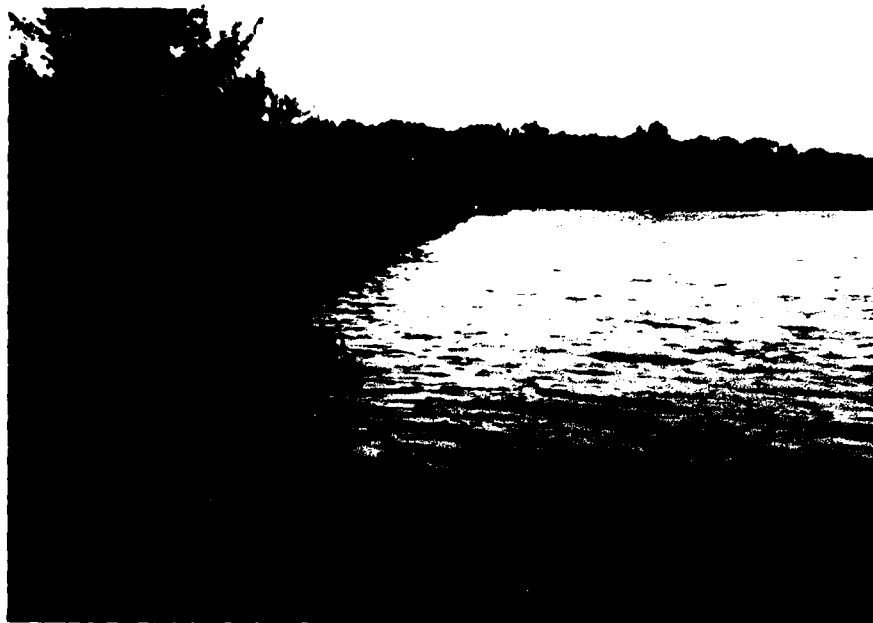
PHOTO 3: FACE OF DAM

The only erosion observed was at several isolated spots in the riprap slope protection on the upstream face where clay (CL) material was being eroded. The upstream face is covered with a heavy growth of brush and small trees which hindered the inspection. The upstream face near the right abutment is protected by a concrete wall extending 1 to 2 feet above normal pool level with a sand beach area downstream and to the right of the wall. No evaluation could be made of erosion protection on the upstream face in those areas where observations were hindered.

The maintenance program should be expanded to repair riprap in the areas of erosion and to control brush and tree growth on the embankment. Mowing of the embankment should be continued to discourage animal burrowing.
